PESCADERO-BUTANO WATERSHED ASSESSMENT

Final Report

March 5, 2004

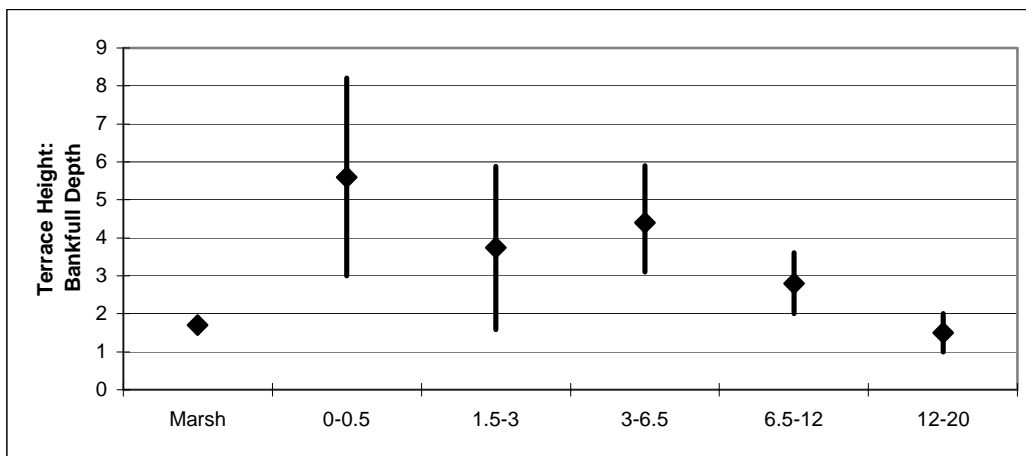
Figure 7-20. Ratio of terrace height to "bankfull" depth in stream channels as a function of channel slope class. This ratio quantifies the relative vertical distance between water elevation at "bankfull" (i.e. field estimated 2-yr recurrence interval flow) and the lowest floodplain surface (often classified in the field as a terrace). High values indicate deep channel entrenchment; low values indicate that the floodplain elevation is low relative to bankfull elevation, suggesting relatively high flooding potential. The diamond indicates the mean value; the line represents the range of one standard error around the mean.

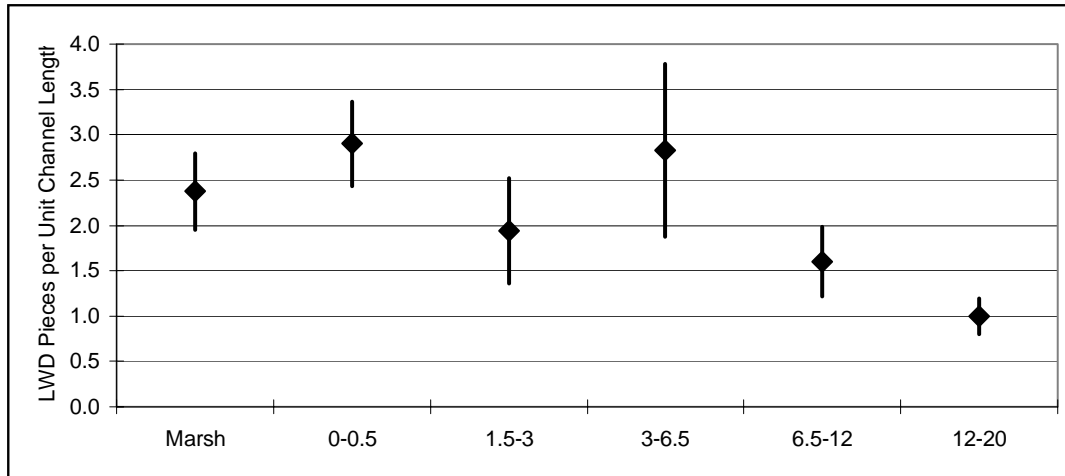
Figure 7-21: LWD per unit channel length (bankfull-width units) as a function of channel slope class. The diamond indicates the mean value; the line represents the range of one standard error around the mean.

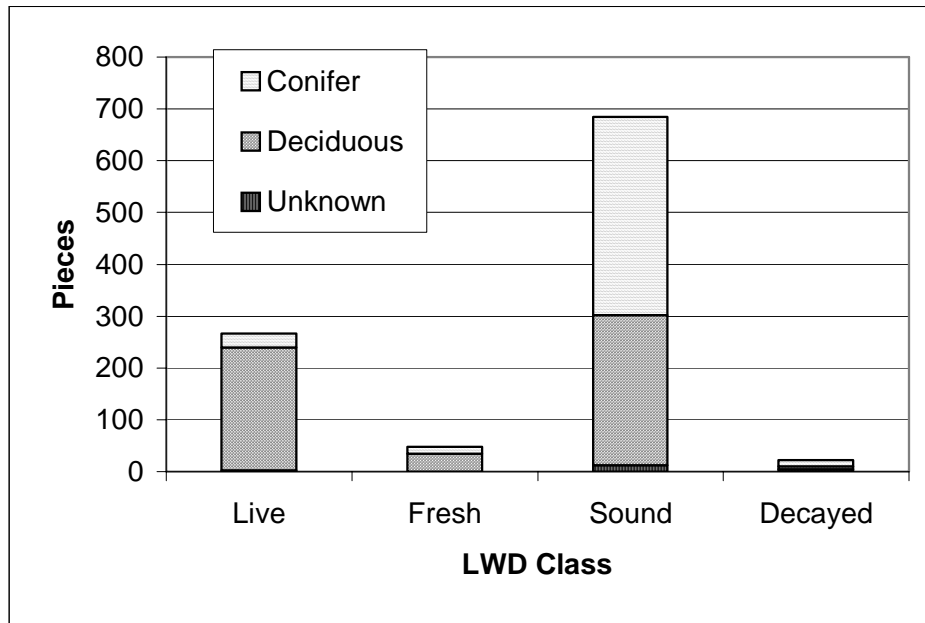
Figure 7-22: Total LWD pieces in each decay class and proportions contributed by coniferous and deciduous trees. The “unknown” type category is negligible. Note the high proportion of live trees that are deciduous.

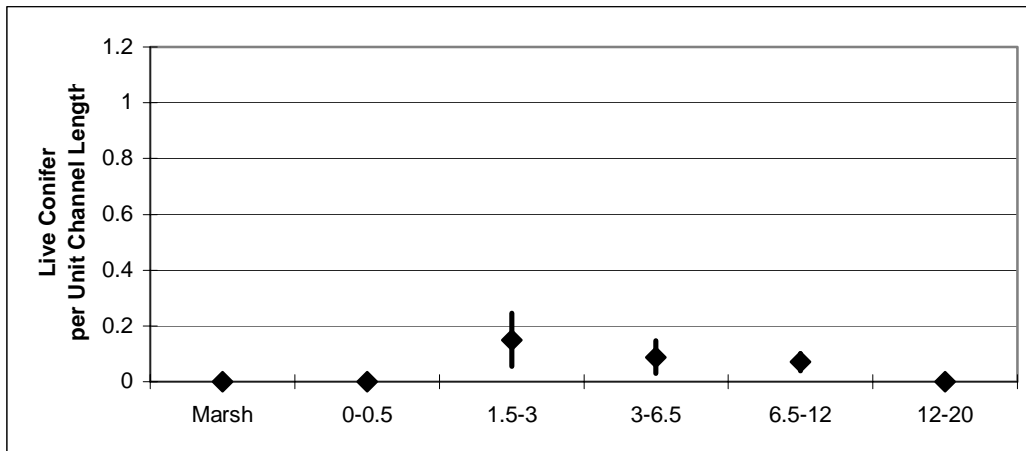
Figure 7-23: Live conifer per unit channel length (bankfull width units) as a function of channel slope class. The diamond indicates the mean value; the line represents the range of one standard error around the mean.

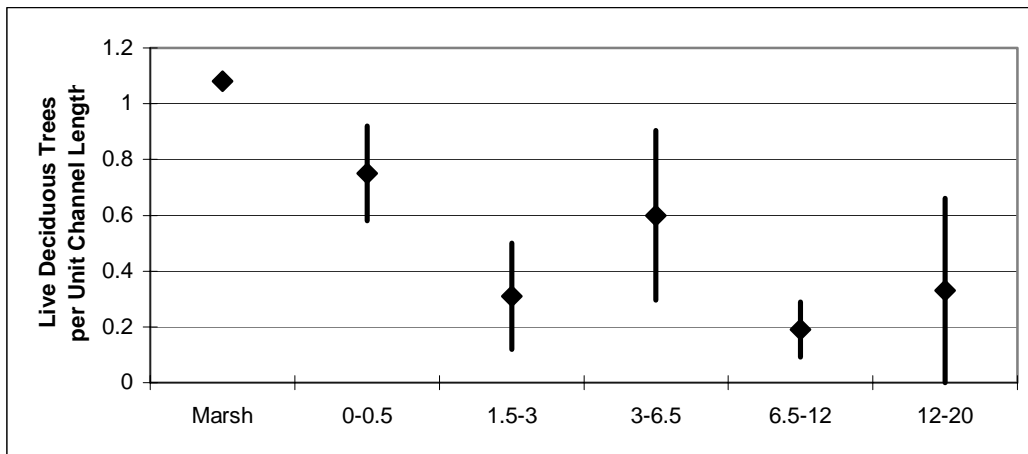
Figure 7-24: Live deciduous trees per unit channel length (bankfull width units) as a function of channel slope class. The diamond indicates the mean value; the line represents the range of one standard error around the mean.

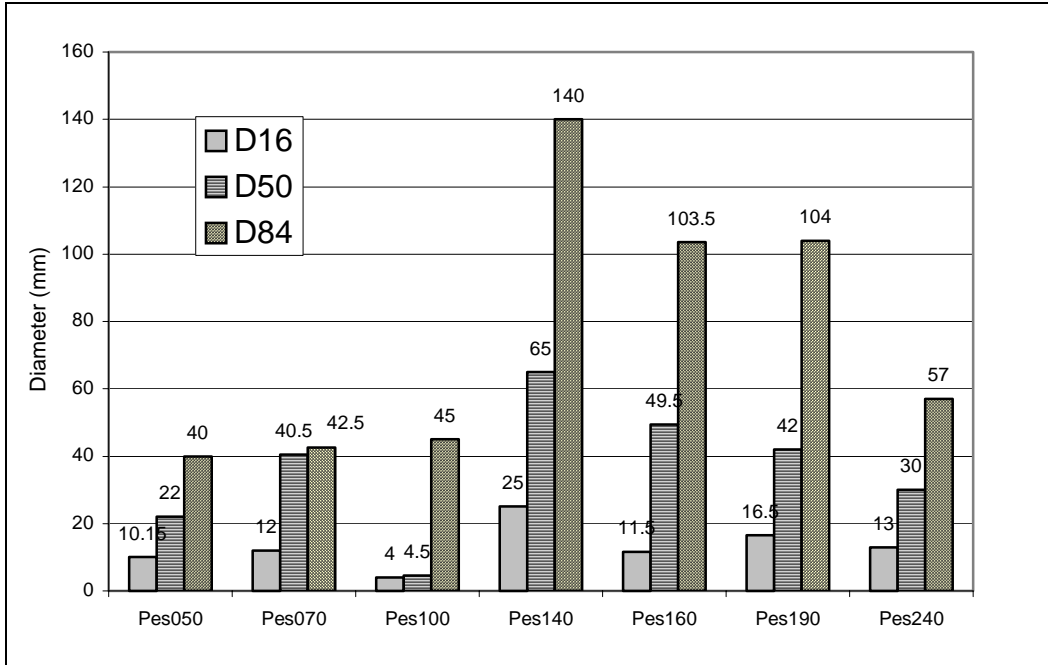
Figure 7-26: Diameters of D16, D50 and D84 for sample reaches ascending Pescadero Creek (from left to right).

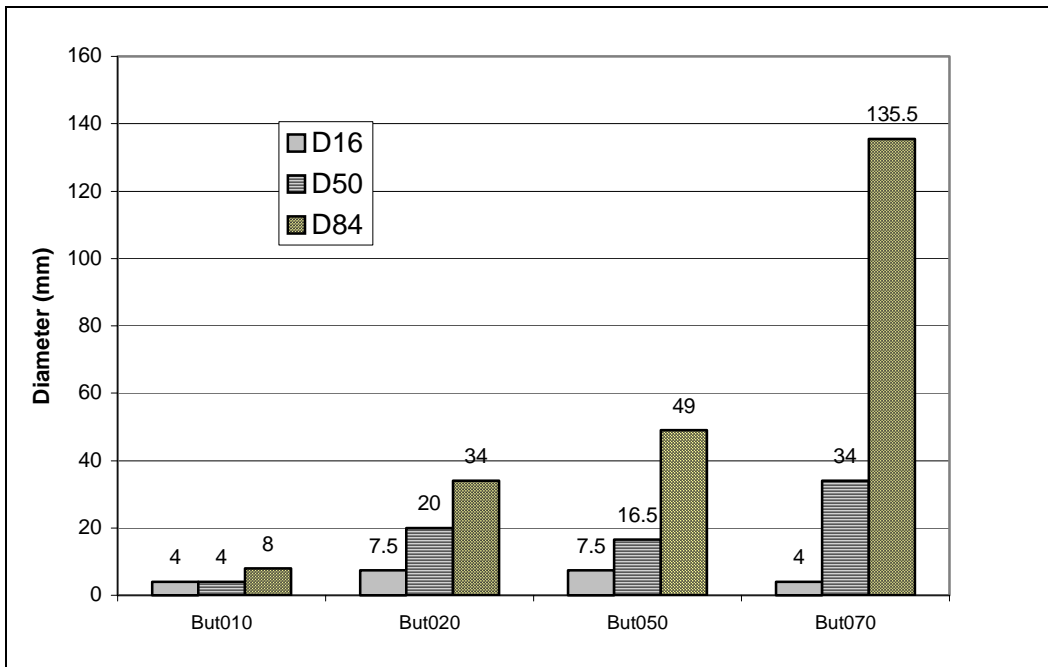
Figure 7-27: Diameters of D16, D50 and D84 for sample reaches ascending Butano Creek (from left to right).

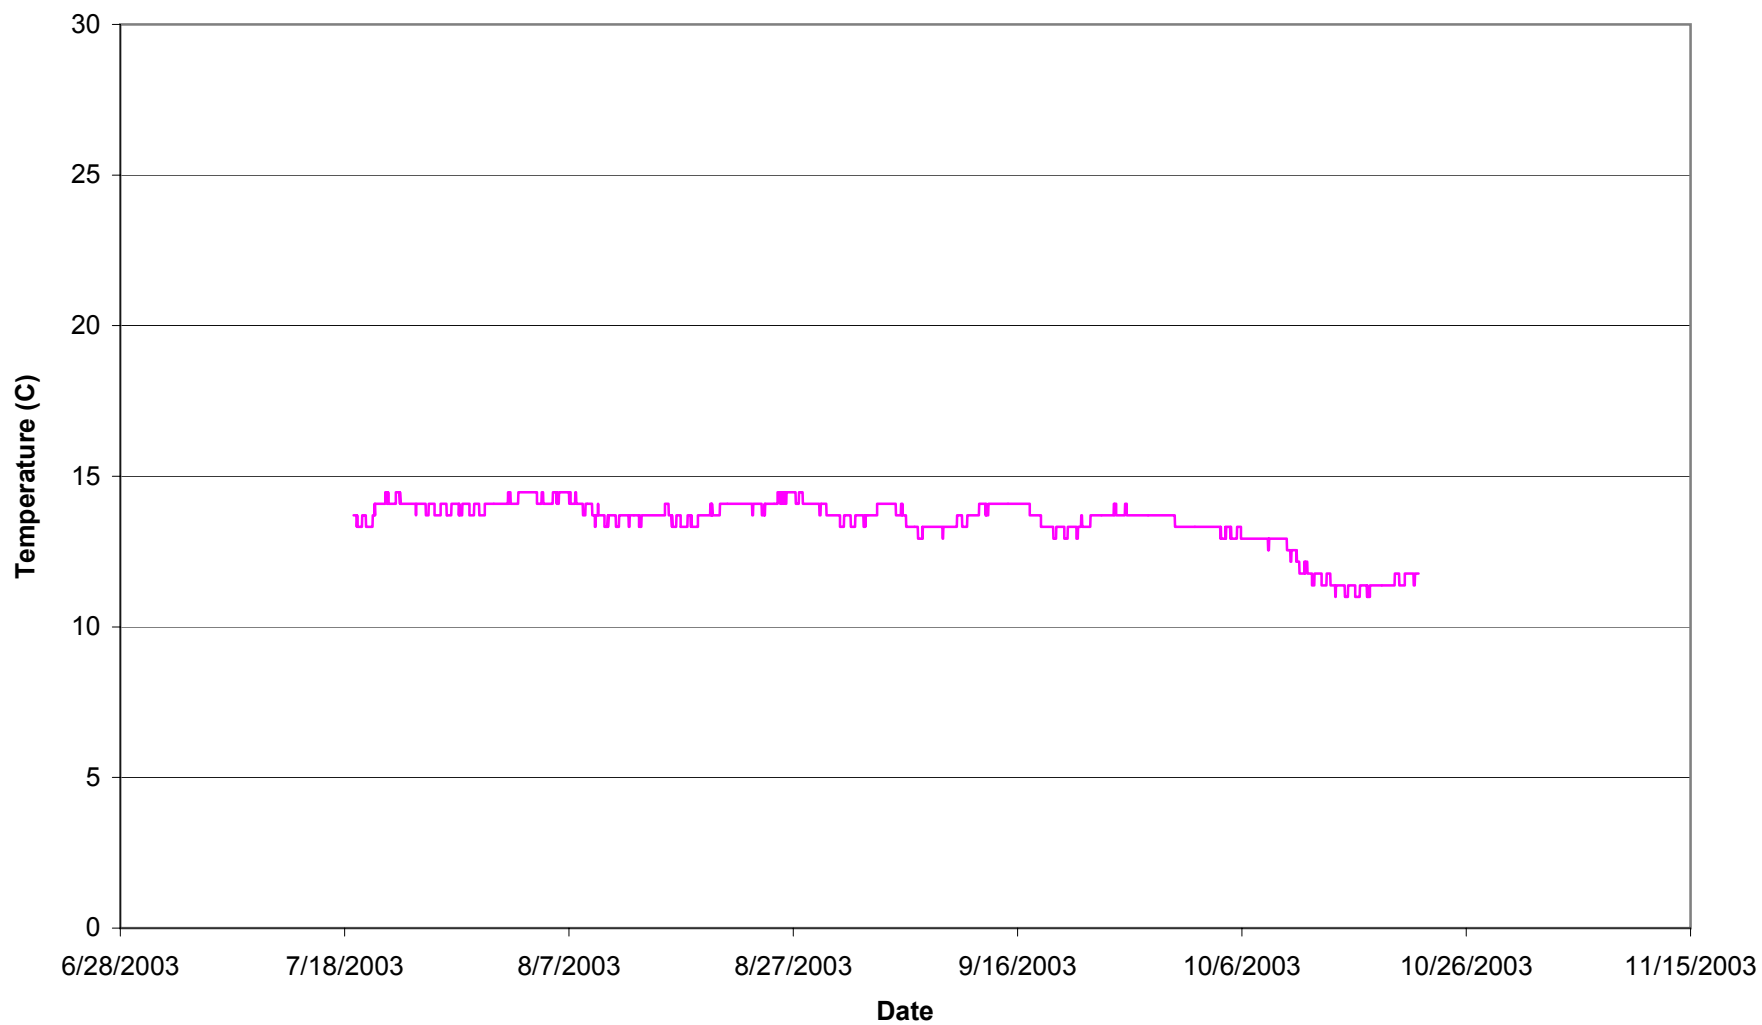
**Stream Temperature:
Pescadero Creek Near Confluence with Honsinger Creek (PES070)**

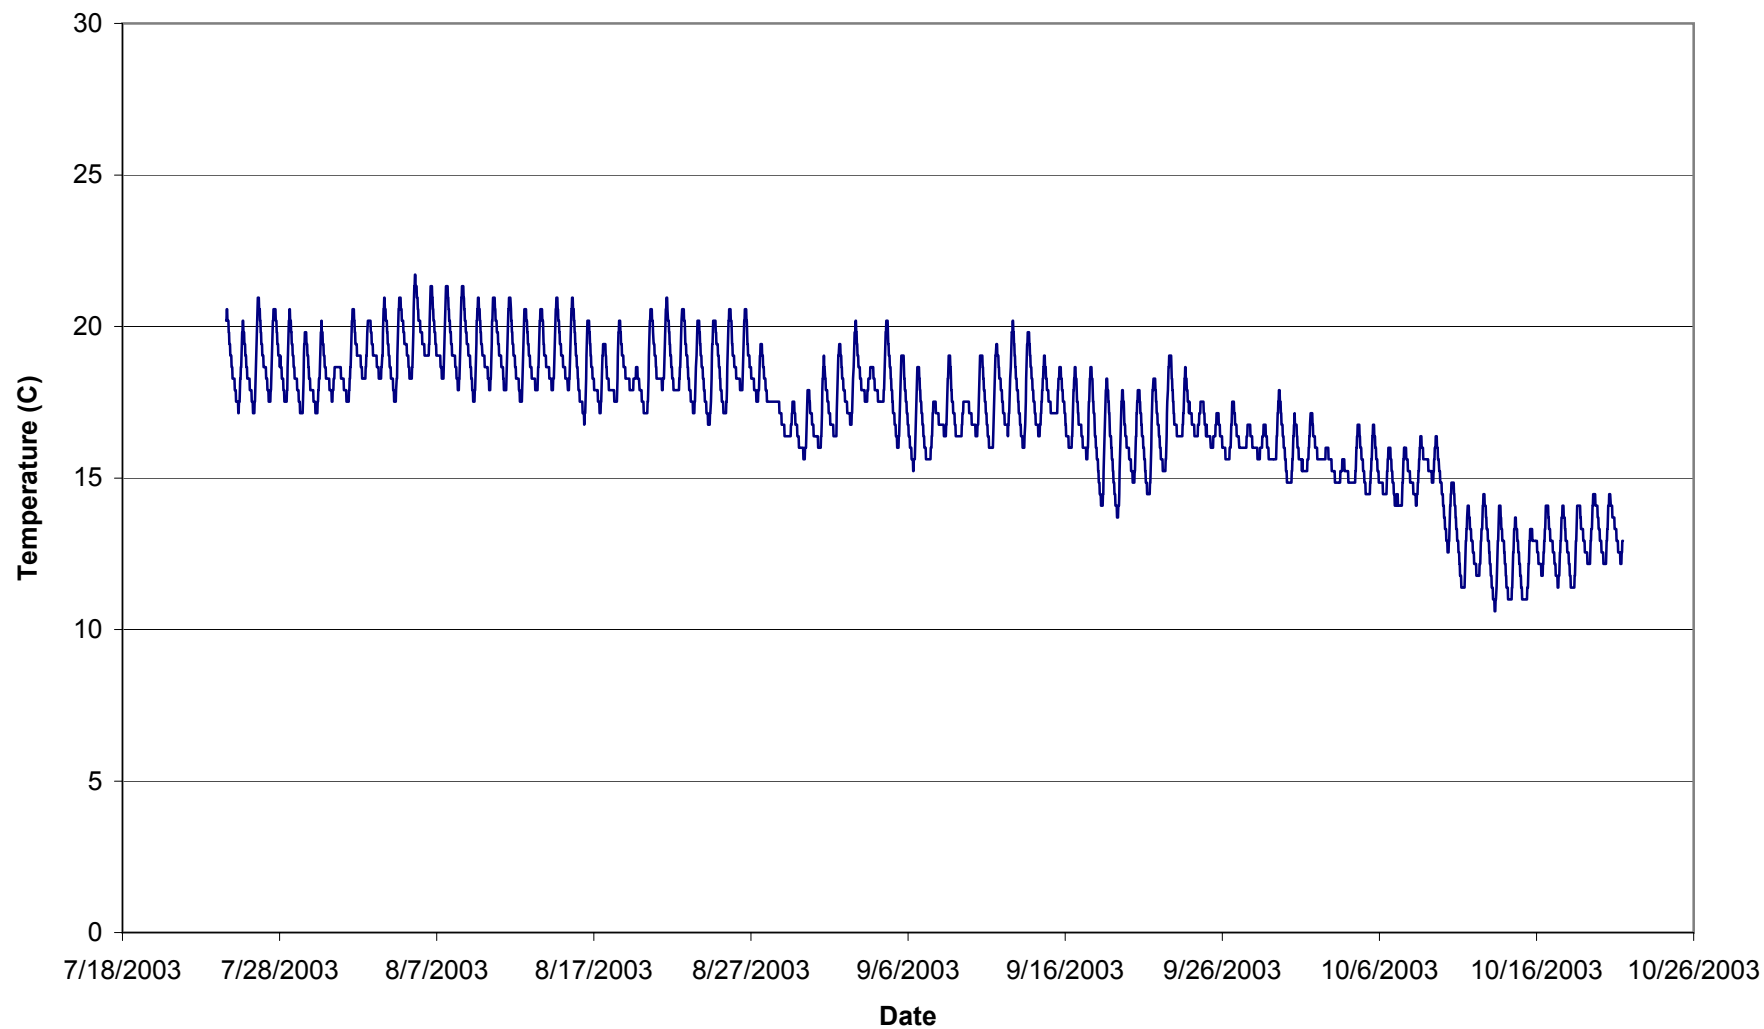
**Stream Temperature:
Pescadero Creek at USGS Gage (PES100)**

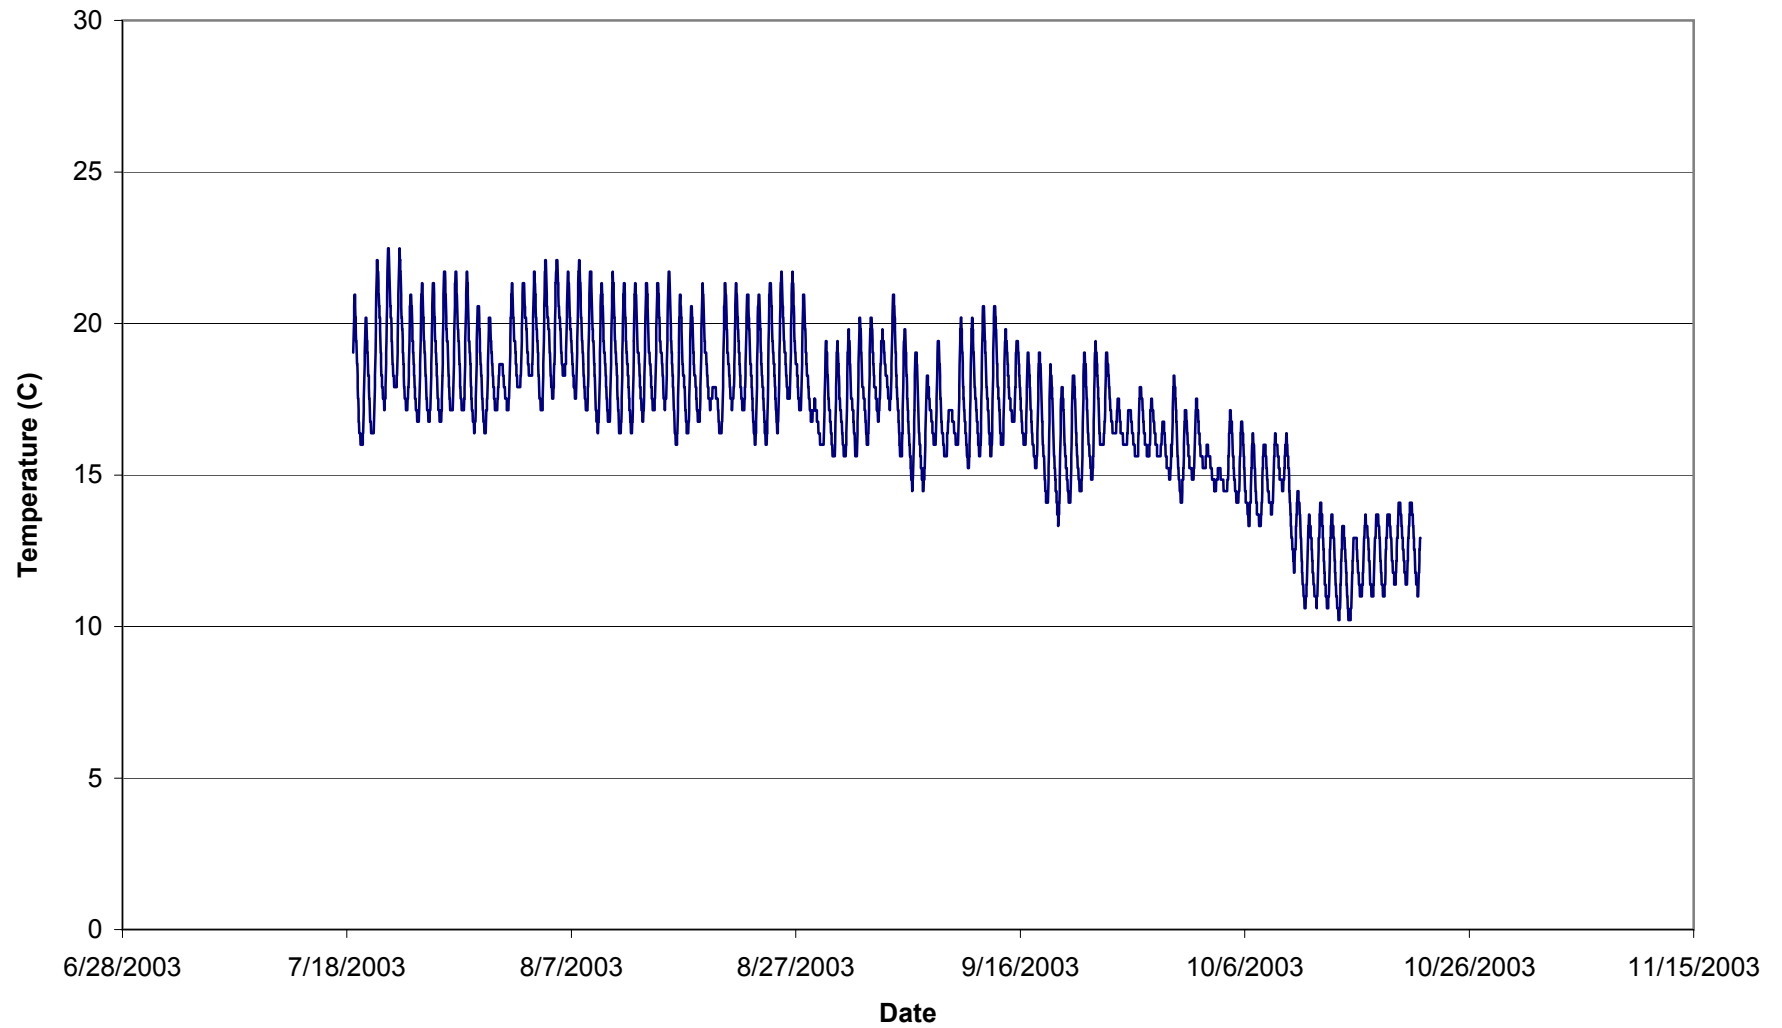
**Stream Temperature:
Pescadero Creek at Towne Fire Road (PES160)**

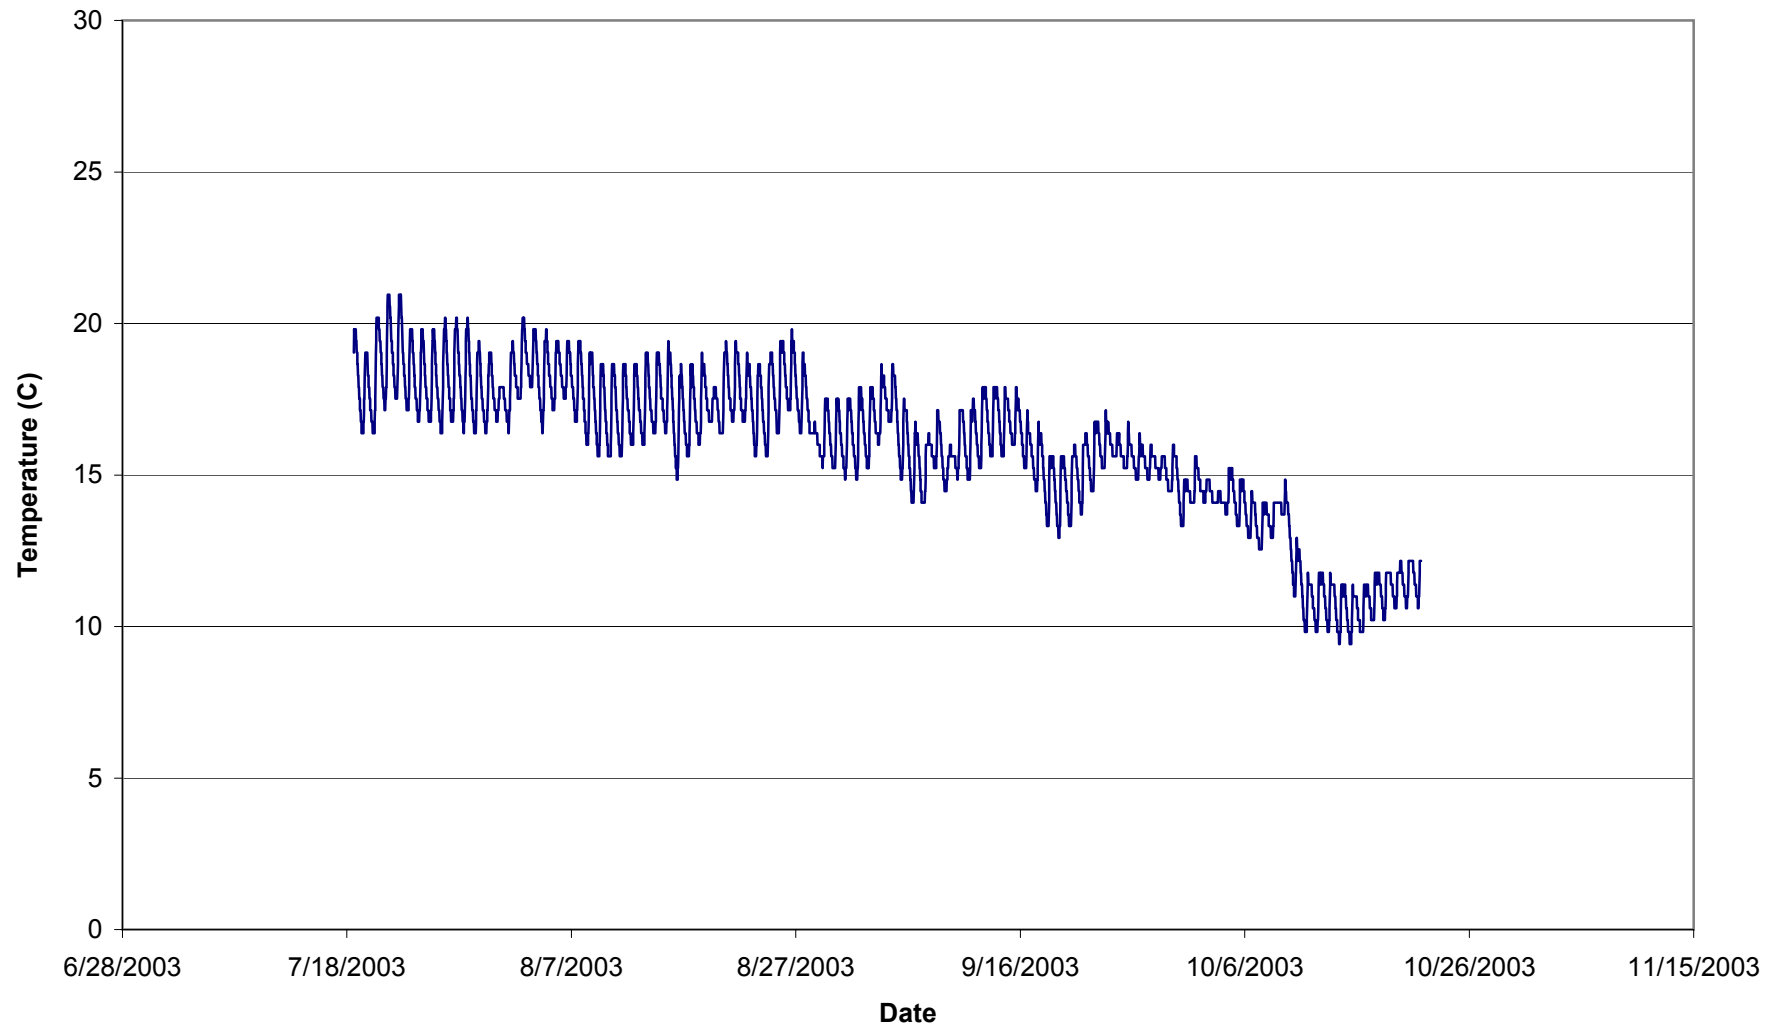
**Stream Temperature:
Tarwater Creek Upstream of Honor Camp Bridge Crossing (PES170)**

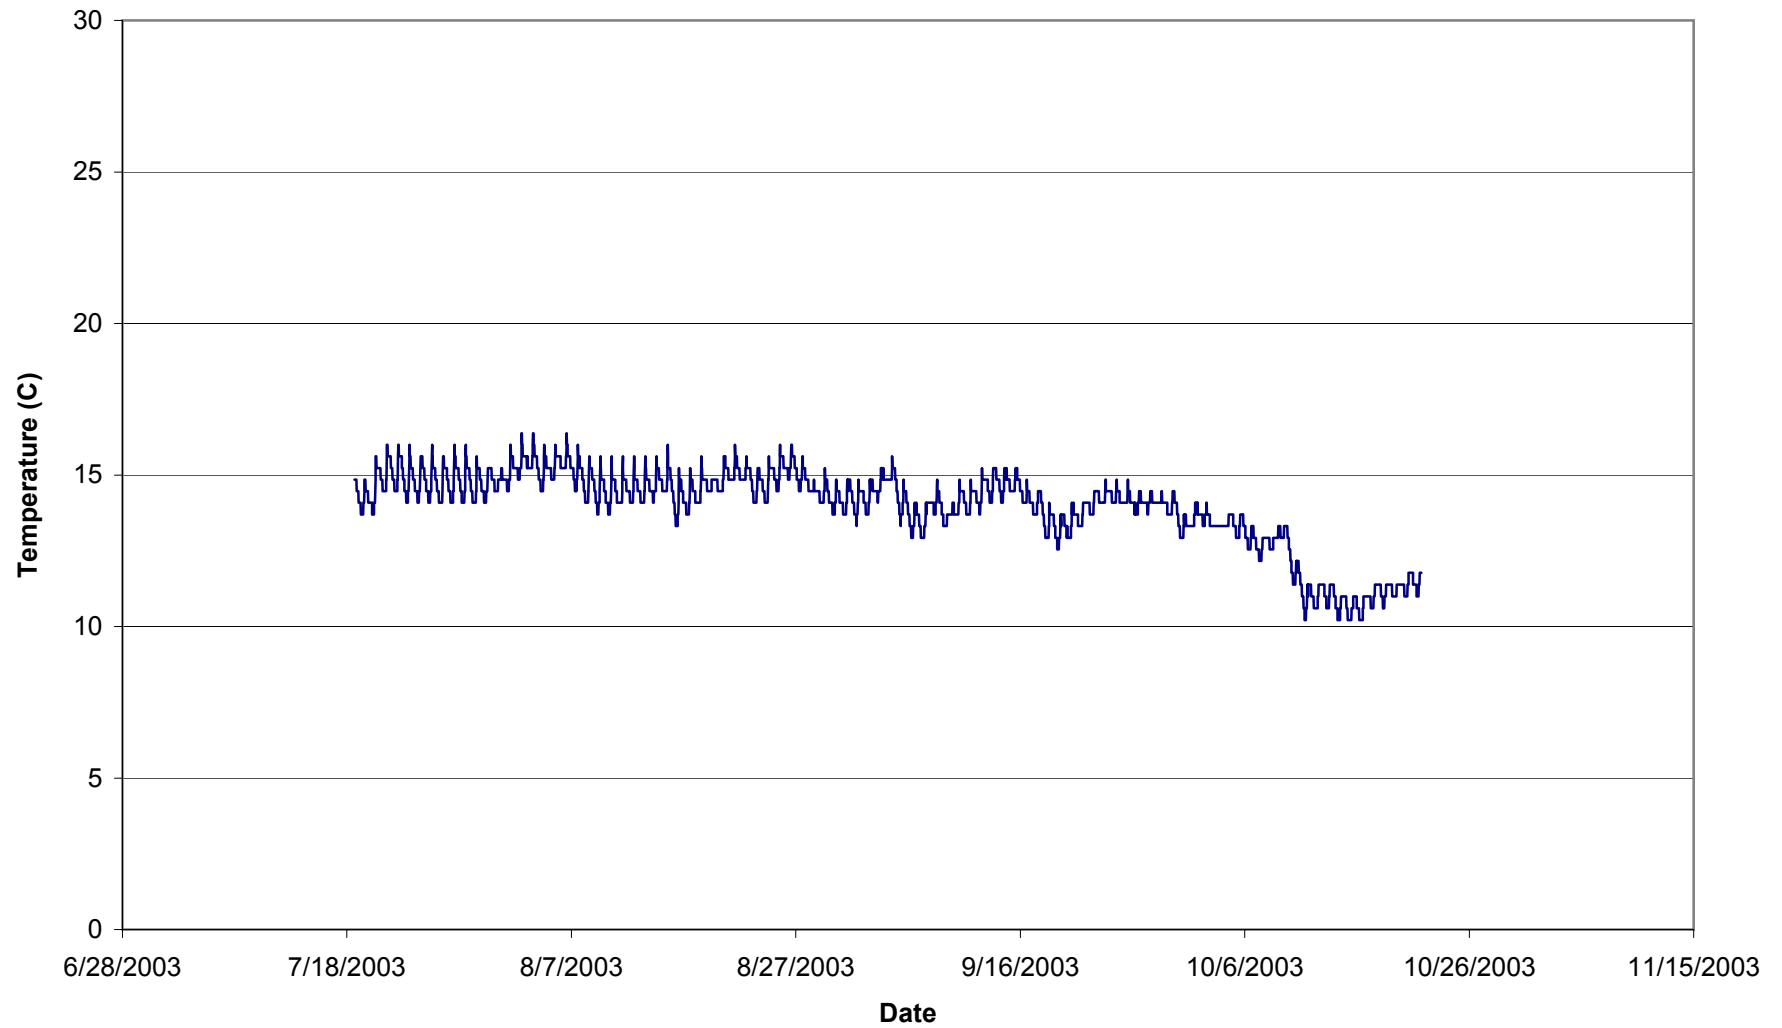
**Stream Temperature:
Peters Creek Near Pescadero Creek (PES180)**

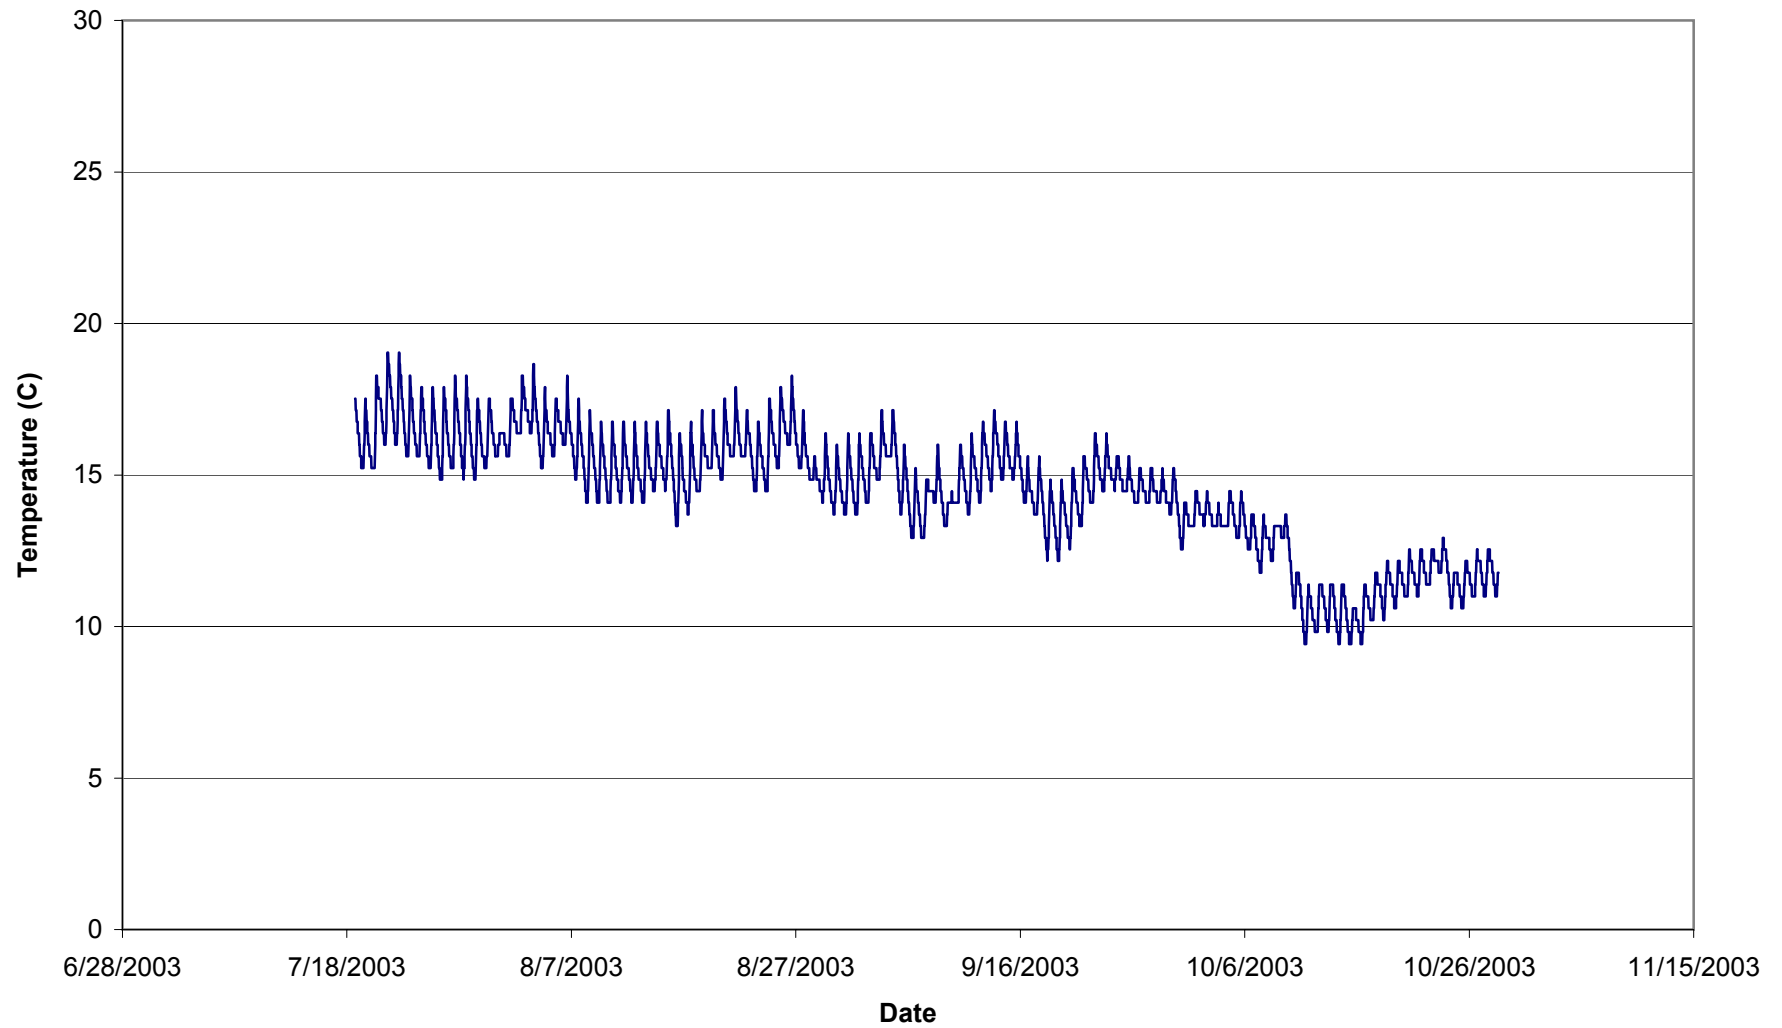
**Stream Temperature:
Pescadero Creek above Peters Creek Confluence (PES190)**

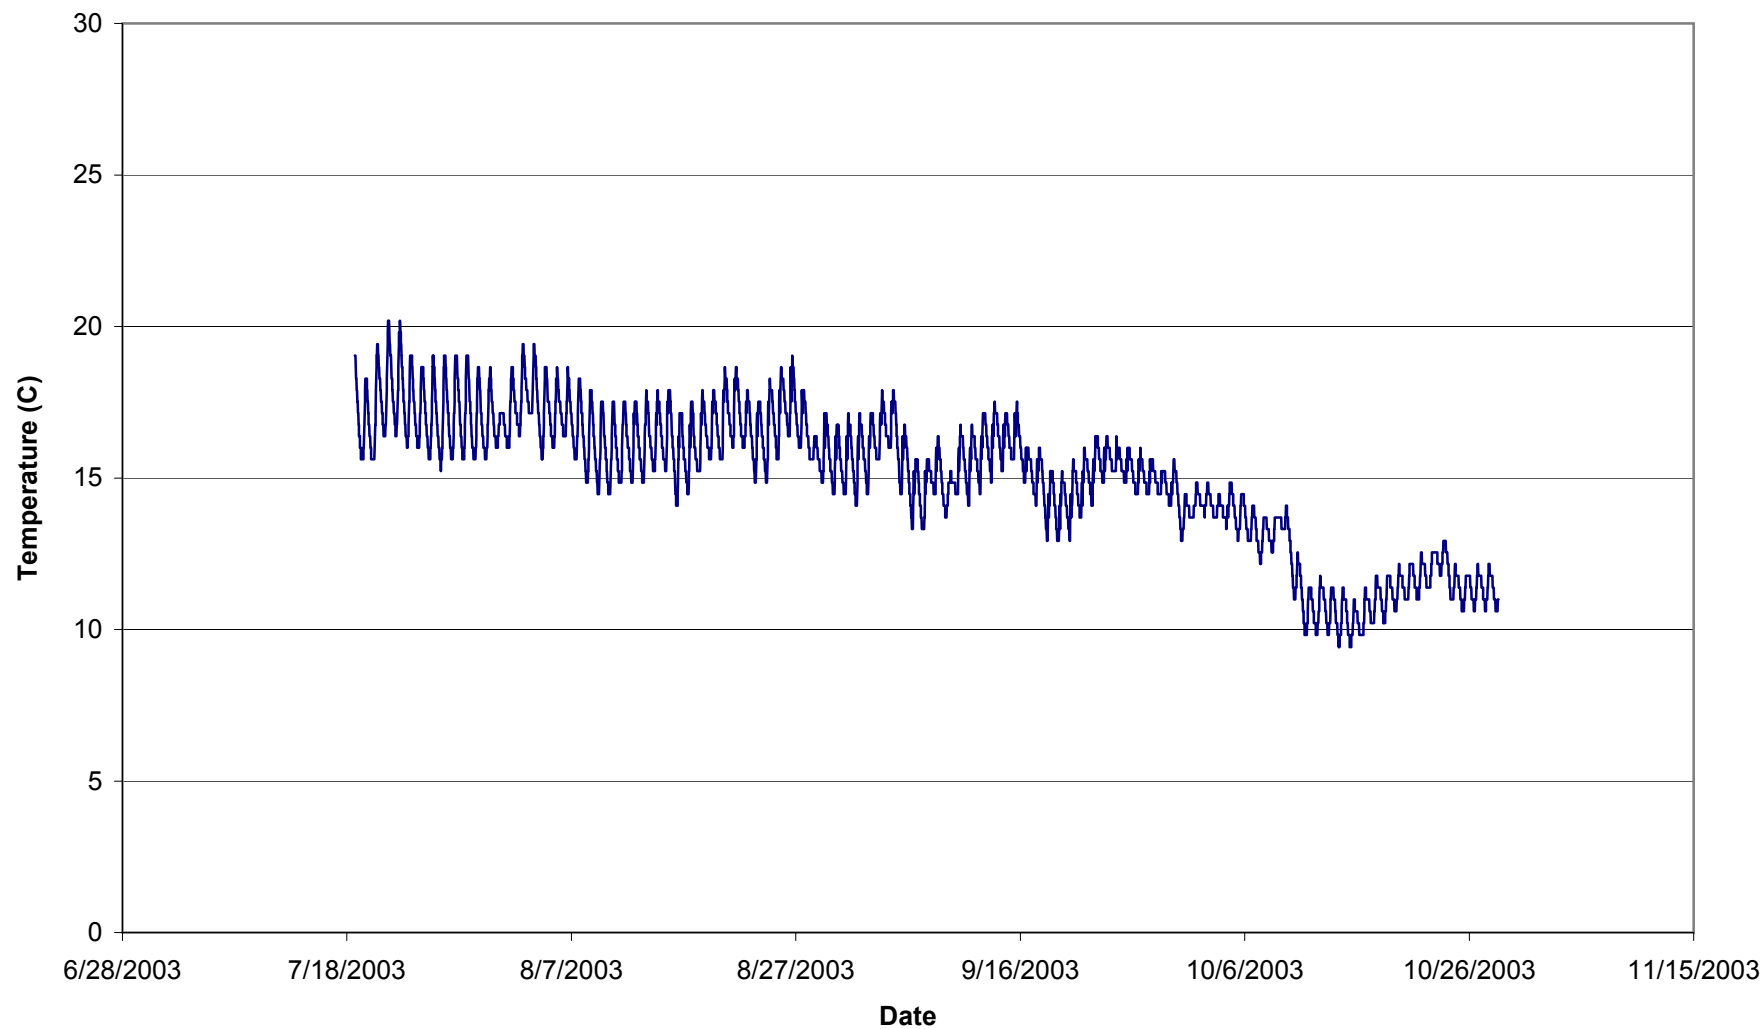
**Stream Temperature:
Slate Creek near Pescadero Creek Confluence (PES205)**

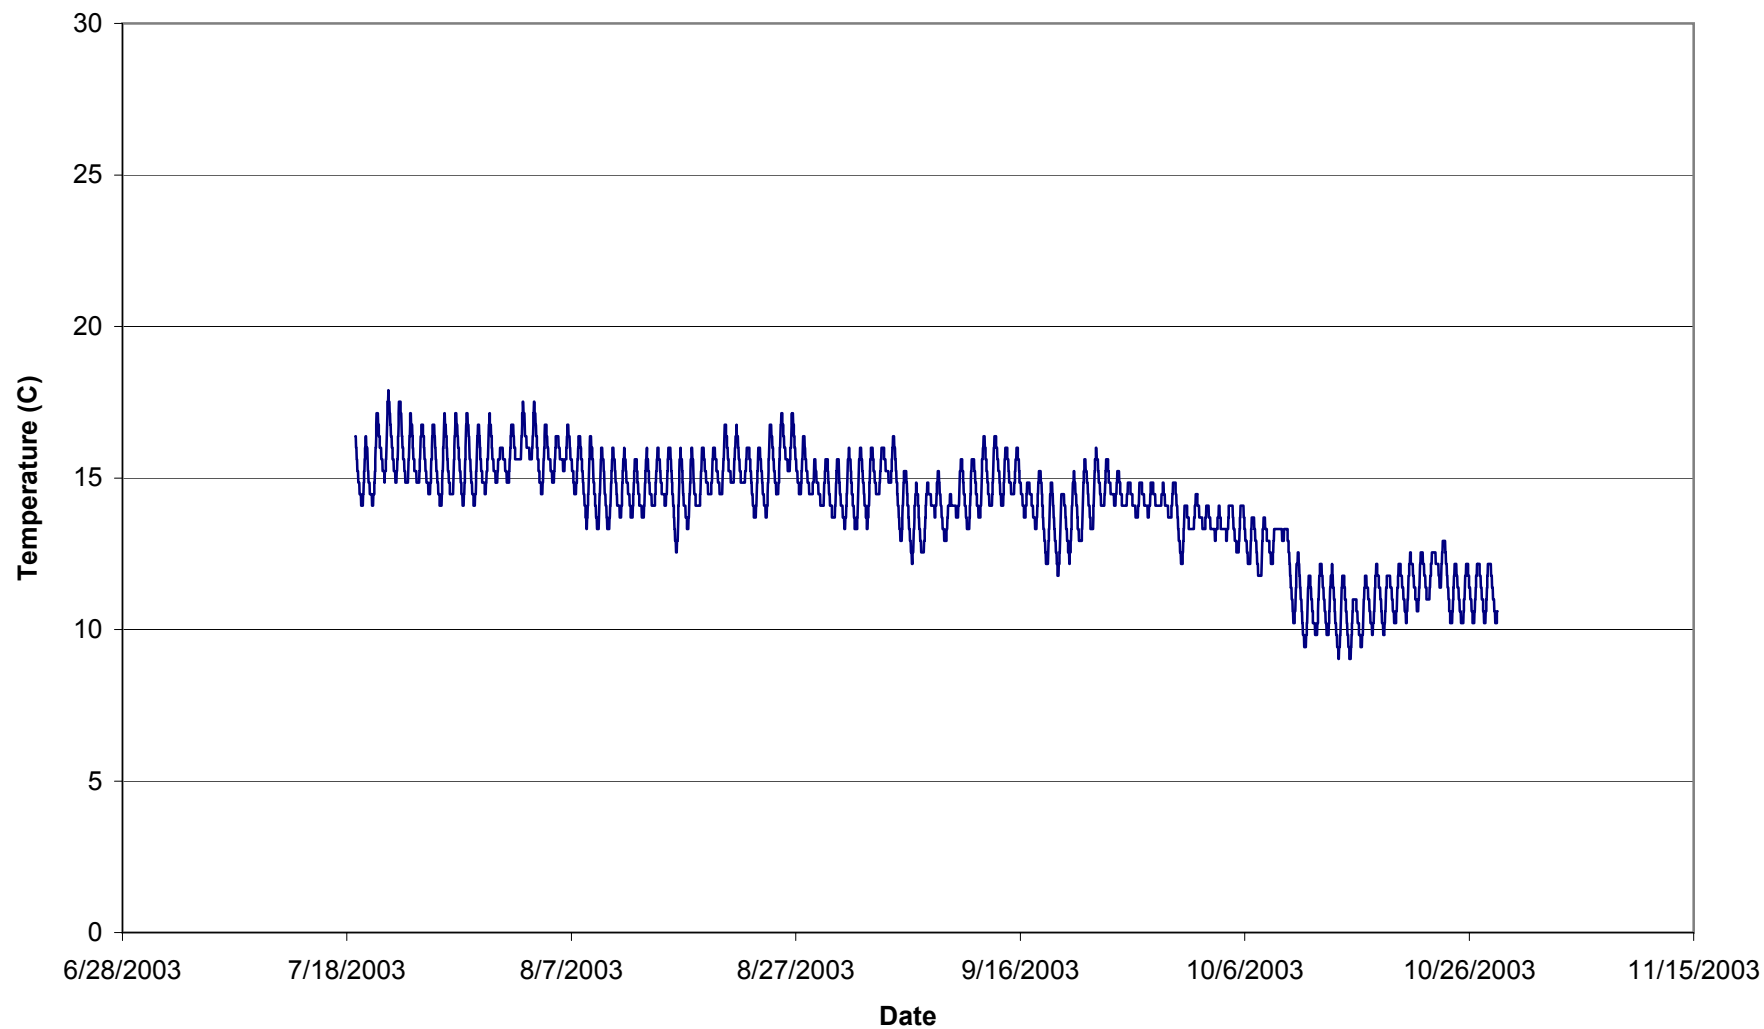
**Stream Temperature:
Oil Creek -- Upper Site (PES215)**

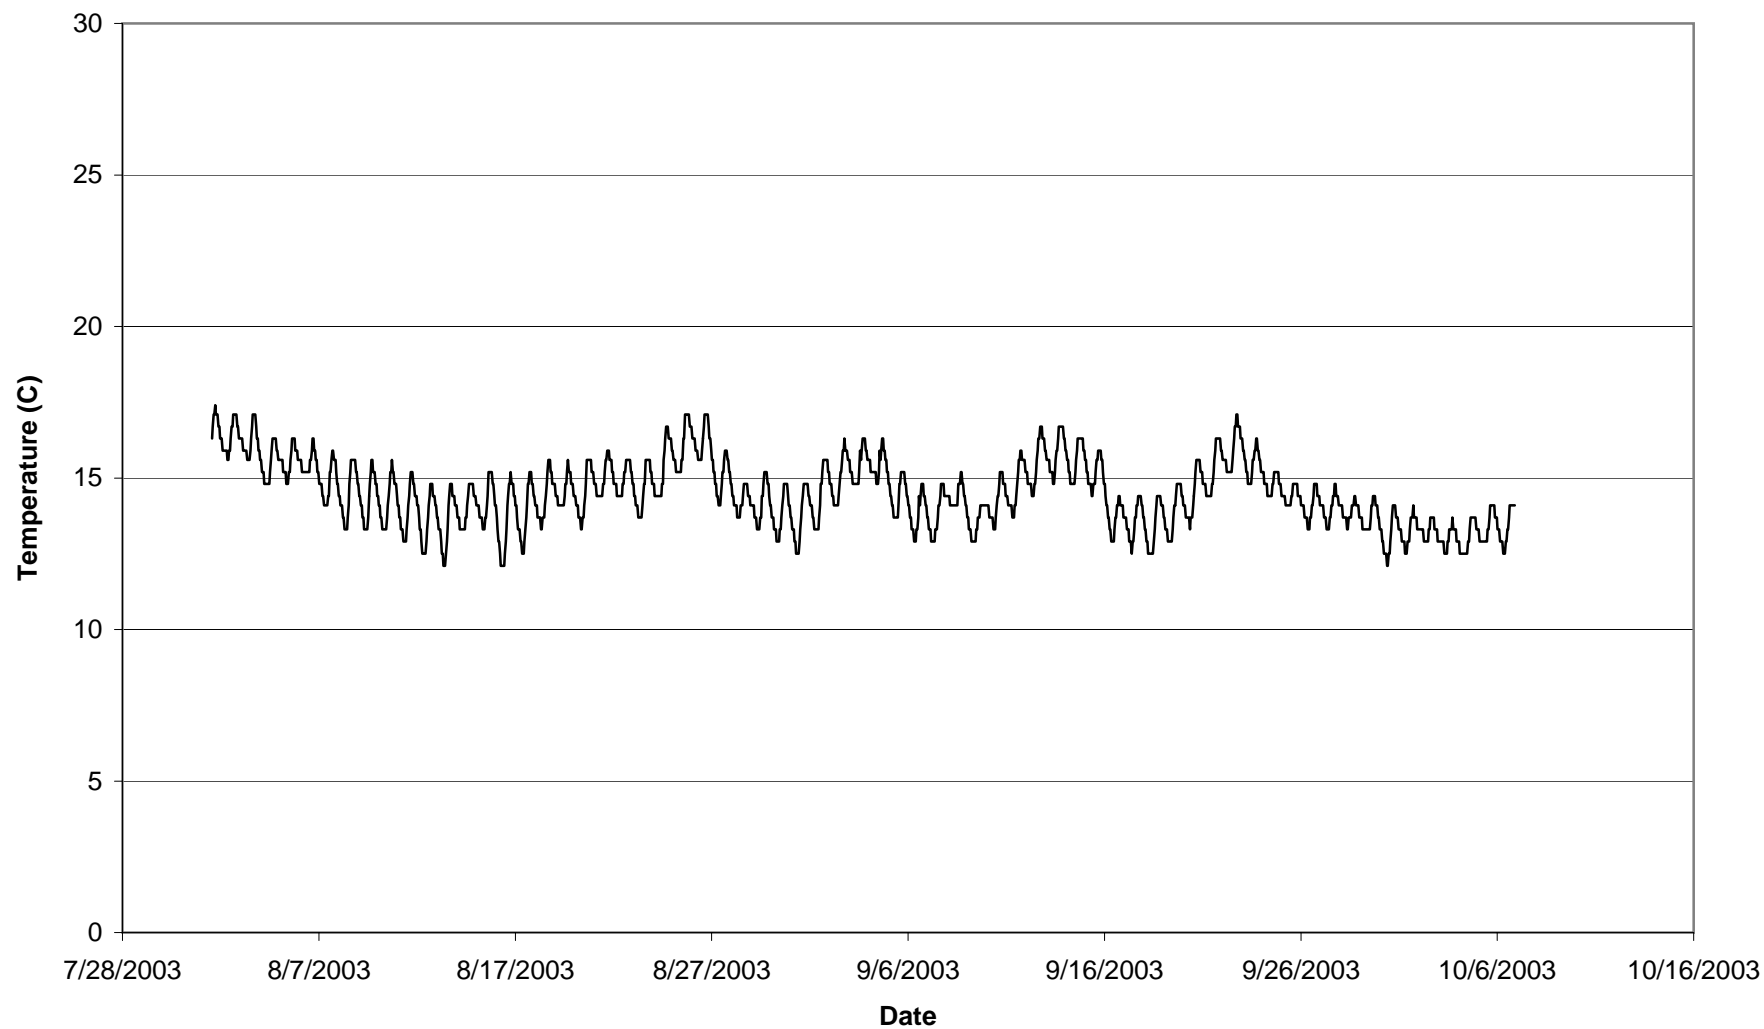
**Stream Temperature:
Waterman Creek (PES235)**

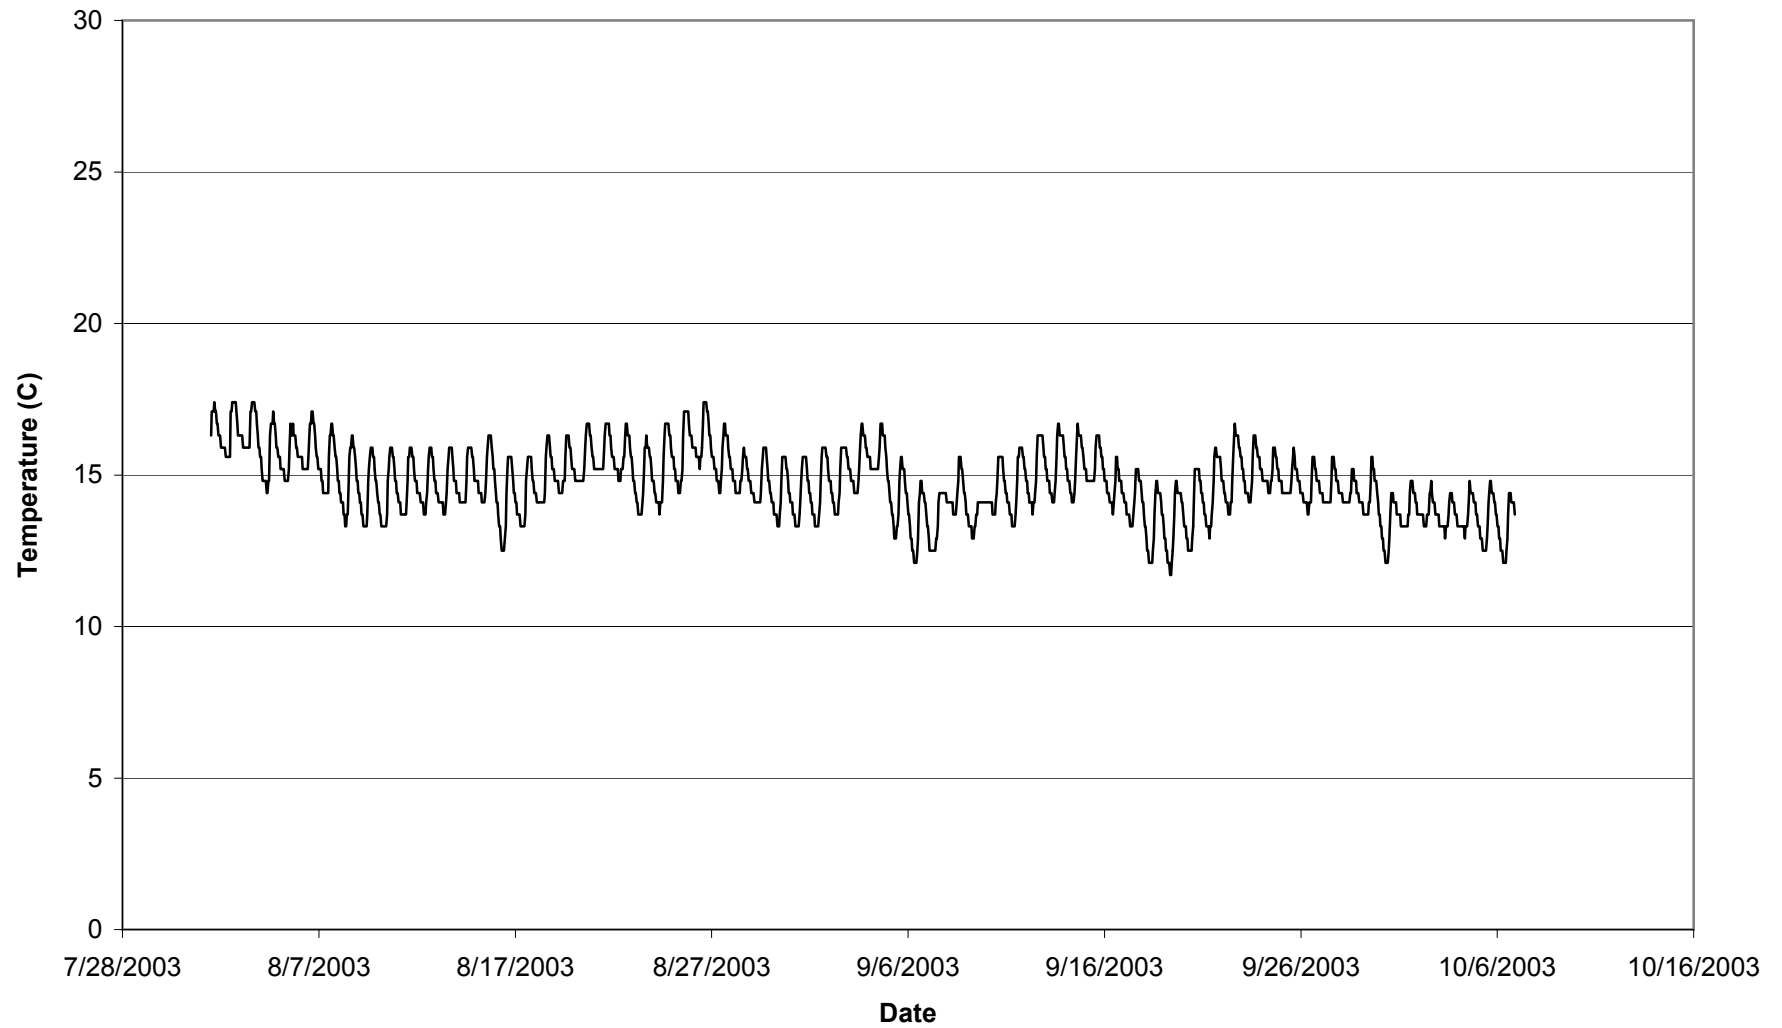
**Stream Temperature:
Little Butano Creek at Butano State Park (BUT050)**
